The typology, frequency and magnitude of some behaviour events in case of torrential hydrographical management works in the upper Tărlung watershed

I. Clinciu, I. C. Petrișan, M. D. Niță, N. C. Tudose

Clinciu I., Petrișan I. C., Niță M. D., Tudose N. C. 2010. The typology, frequency and magnitude of some behaviour events in case of torrential hydrographical management works in the upper Tărlung watershed. *Ann. For. Res.* 53(2): 161-174, 2010.

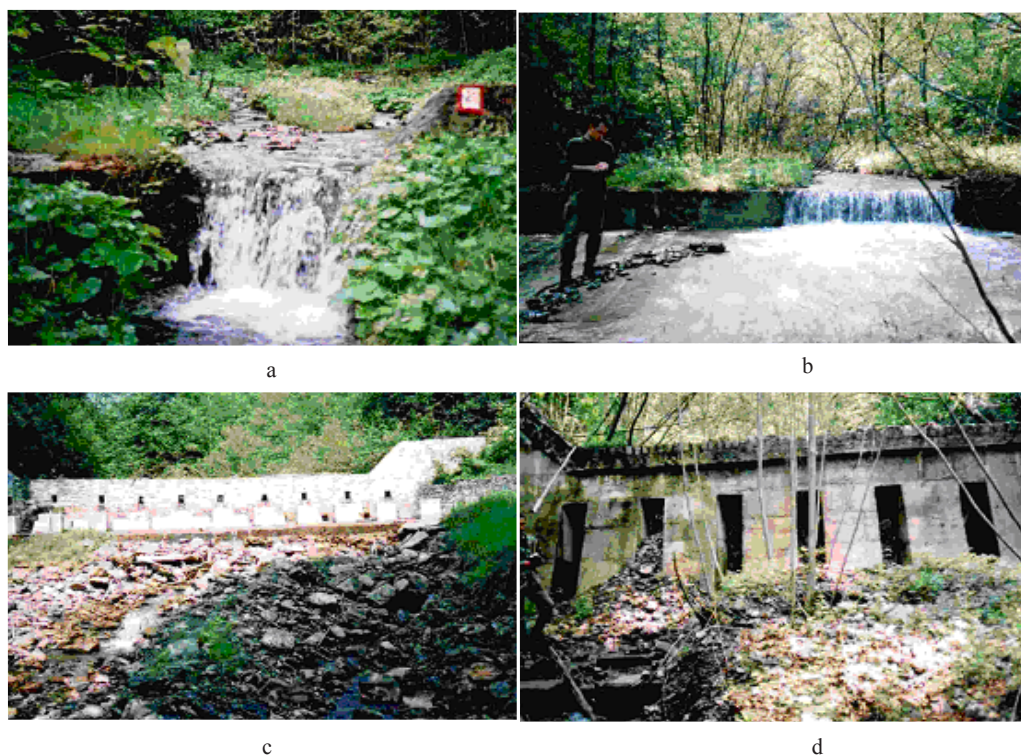
Figure 1 Torrential hydrographical management works in the Tărlung Valley at 20 (25) years from their construction

Note: (a) The 1M0/2,0 traverse in the de sub Stânci Brook, (b) The 3B0,5 sill in the the Zimbrului Valley, (c) The 7M2,0 dam in the Adânc de Sus Brook, (d) The 4B4,0 dam in the Tare Brook (Photographs: Clinciu, 2003).

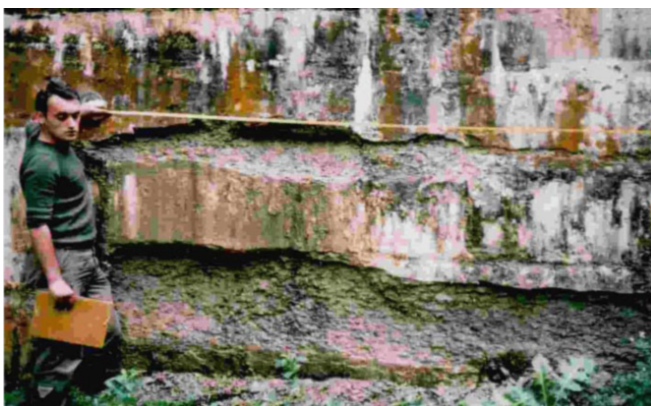
As far as the body of the overflowed area is concerned (the most affected component part - Fig.7), the frequency and the magnitude (intensity) of the damages were examined using

Concentrating on the parts where the examined damages were discovered (and respectively identified), we can notice (Fig. 6-7) that the highest degradation frequency in the case of transverse hydrotechnical works, is displayed by the body corresponding to the overflowed area, eroded in 43 out of the 52 examined cases; with equal frequencies (6 each), follow the apron and the energy dissipating teeth; only two cases of erosive damages were identified for the right wing and one for the body of the un-overflowed area – the right side, the body corresponding to the un-overflowed area (left side) and the left wing.

Figure 7 The dam 8B3,0 in Zimbrului Valley degraded by water and alluvia erosion in the area of the overflowed body (Photo: Clinciu 2003).
