The typology, frequency and magnitude of some behaviour events in case of torrential hydrographical management works in the upper Tărlung watershed

I. Clinciu, I. C. Petrișan, M. D. Niță, N. C. Tudose

Clinciu I., Petrișan I. C., Niță M. D., Tudose N. C. 2010. The typology, frequency and magnitude of some behaviour events in case of torrential hydrographical management works in the upper Tărlung watershed. *Ann. For. Res.* 53(2): 161-174, 2010.

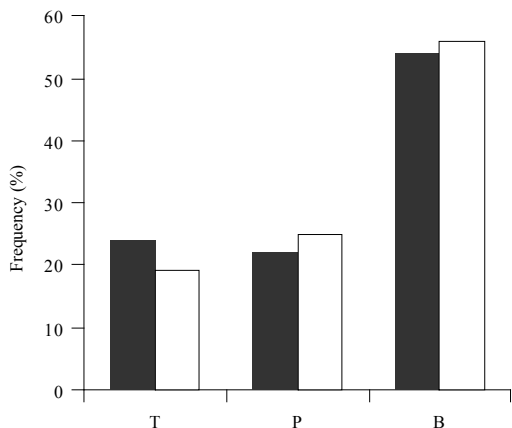
Figure 5 Comparison between the frequency of the erosive damage and the typological frequency of the works, in the case of transverse hydrotechnical works
T – traverses; P – sills; B – dams; In black: the typological frequency (%); In white: the extent of the erosive damage (%)

According to the type of transverse hydrotechnical works, the situation is as follows (Fig. 5): out of the 52 affected works, a number of 29 (56%) are dams, a number of 13 (25%) represent sills and a number of 10 (19%) represent traverses. Correlating this situation with the examined types of works (where the dams represent 55%, sills 22% and traverses 25%), we can infer that the degradation was more frequent among sills and dams and less frequent among traverses. This result is understandable if we take into account that traverses have fewer component parts in direct contact with

the water and the alluvia in movement, which cause the erosive damage to the masonry or concrete.

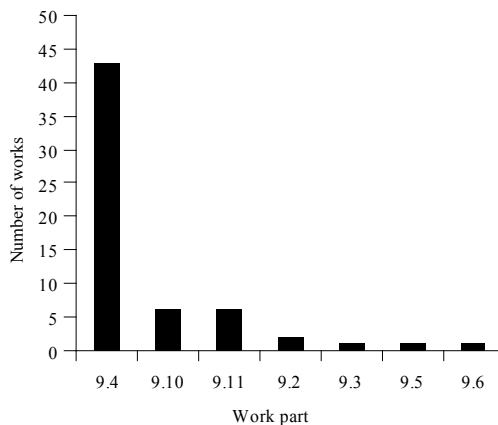
Figure 6 The hierarchy of parts of the works according to their erosive damage frequency
(9.4 - body of the overflowed area; 9.10 - apron; 9.11 - energy dissipating teeth; 9.2 - right wing; 9.3 - body of right undischarged area; 9.5 - body of left undischarged area; 9.6 - left wing)

quency of the erosive damages of works, while figure 6 presents a hierarchy of the constituent parts of a traverse hydrotechnical work in the order of the occurrence frequency of the examined damage.

As far as the body of the overflowed area is concerned (the most affected component part - Fig.7), the frequency and the magnitude (intensity) of the damages were examined using

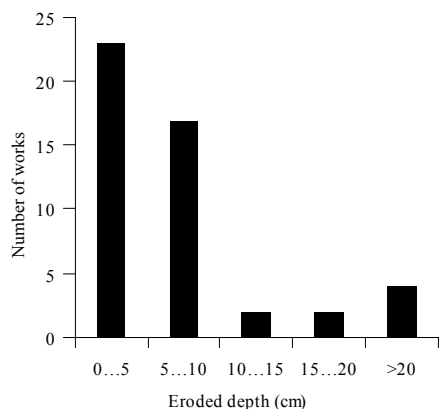
Figure 8 The erosive damage frequency according to the depth of eroded area

Represented graphically (Fig. 8 and Fig. 9), the above mentioned data offer a first image of the magnitude of the damages; indeed, judging by the two criteria, we can notice that only 13% of the cases of erosive damage in the overflowed area are deep or very deep and only 10% of these cases display very extensive or highly extensive damaged surfaces.

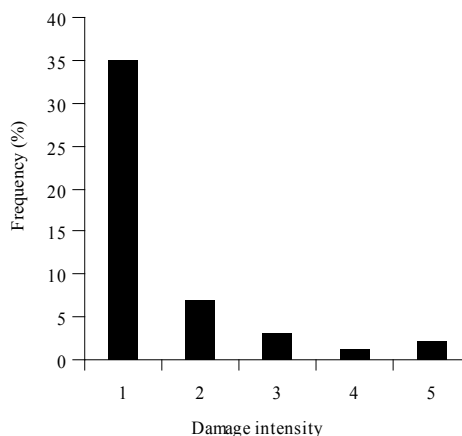
Figure 11 The frequency of works degraded by the erosion of water and alluvia according to the intensity classes of these damages

Because the numbers entered in the cells represent the number of cases (frequencies), by adding them, separately for each area, the following frequencies were obtained according to the degrees of damage intensity (Fig.11): very low intensity: 35 cases (72.34%); low intensity: 7 (14.90%); medium intensity: 3 (6.38%); high intensity: 1 (2.13%); very high intensity: 2 (4.25%).
